FLOOD PLAIN INFORMATION

ANTHETAN CREEK AND HEISTERS CREEK
BERKS COUNTY, PENNSYLVANIA

PREPARED FOR THE BERKS COUNTY PLANNING COMMISSION
BY THE CORPS OF ENGINEERS, U.S. ARMY (FUNDING AGENCY)

JUNE 1975

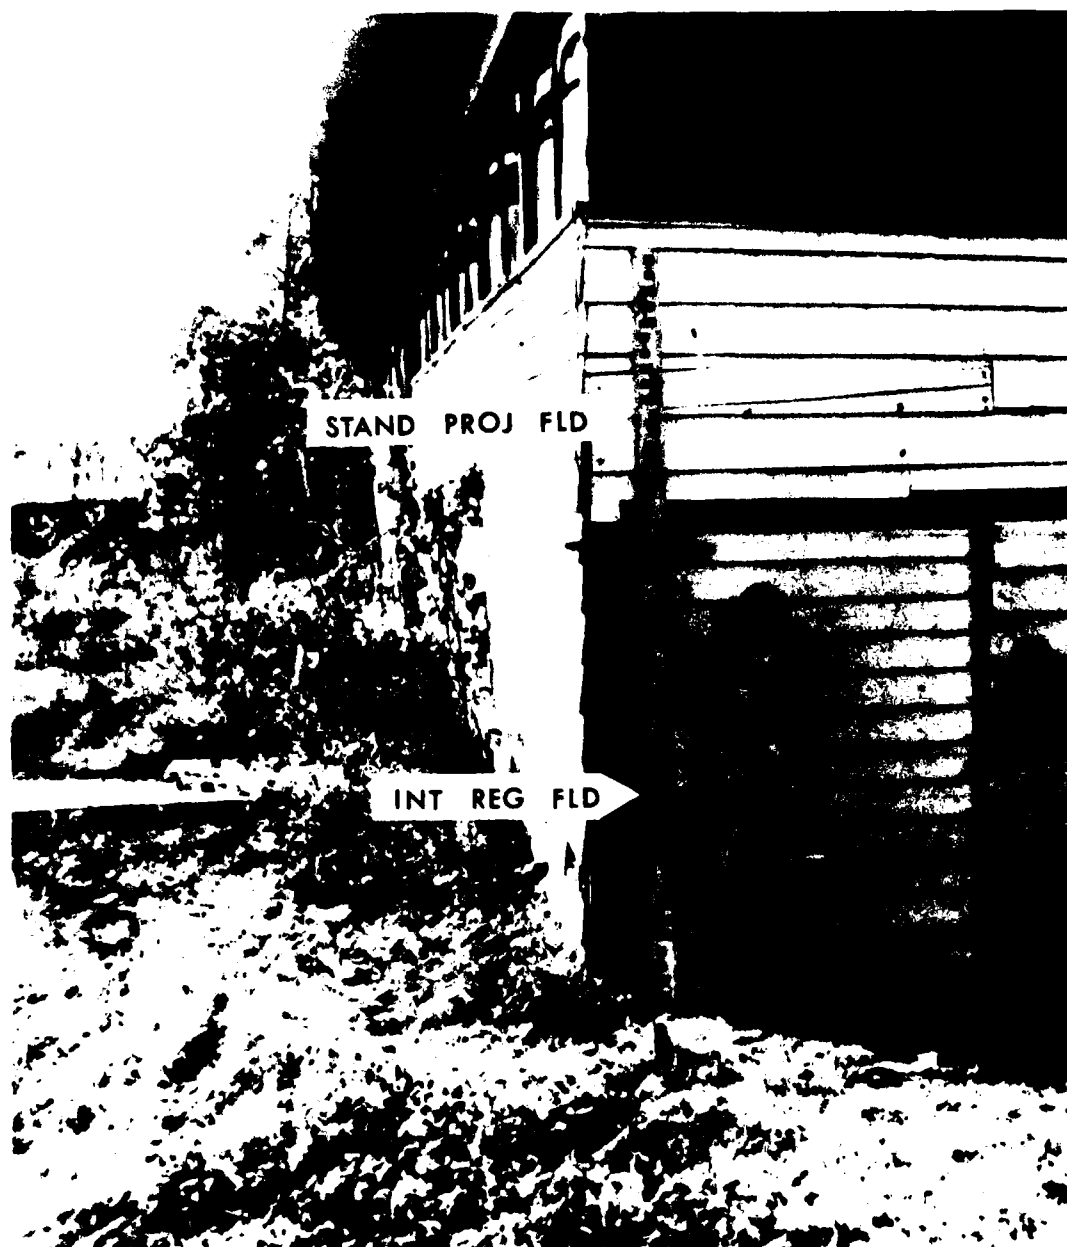
FIGURE 3 - Future flood heights of Antietam Creek at the Reading Country Club Maintenance Building.

Photographs, future flood heights - The levels that the Intermediate Regional and Standard Project Floods are expected to reach at various locations in the study area are indicated on the following photographs.

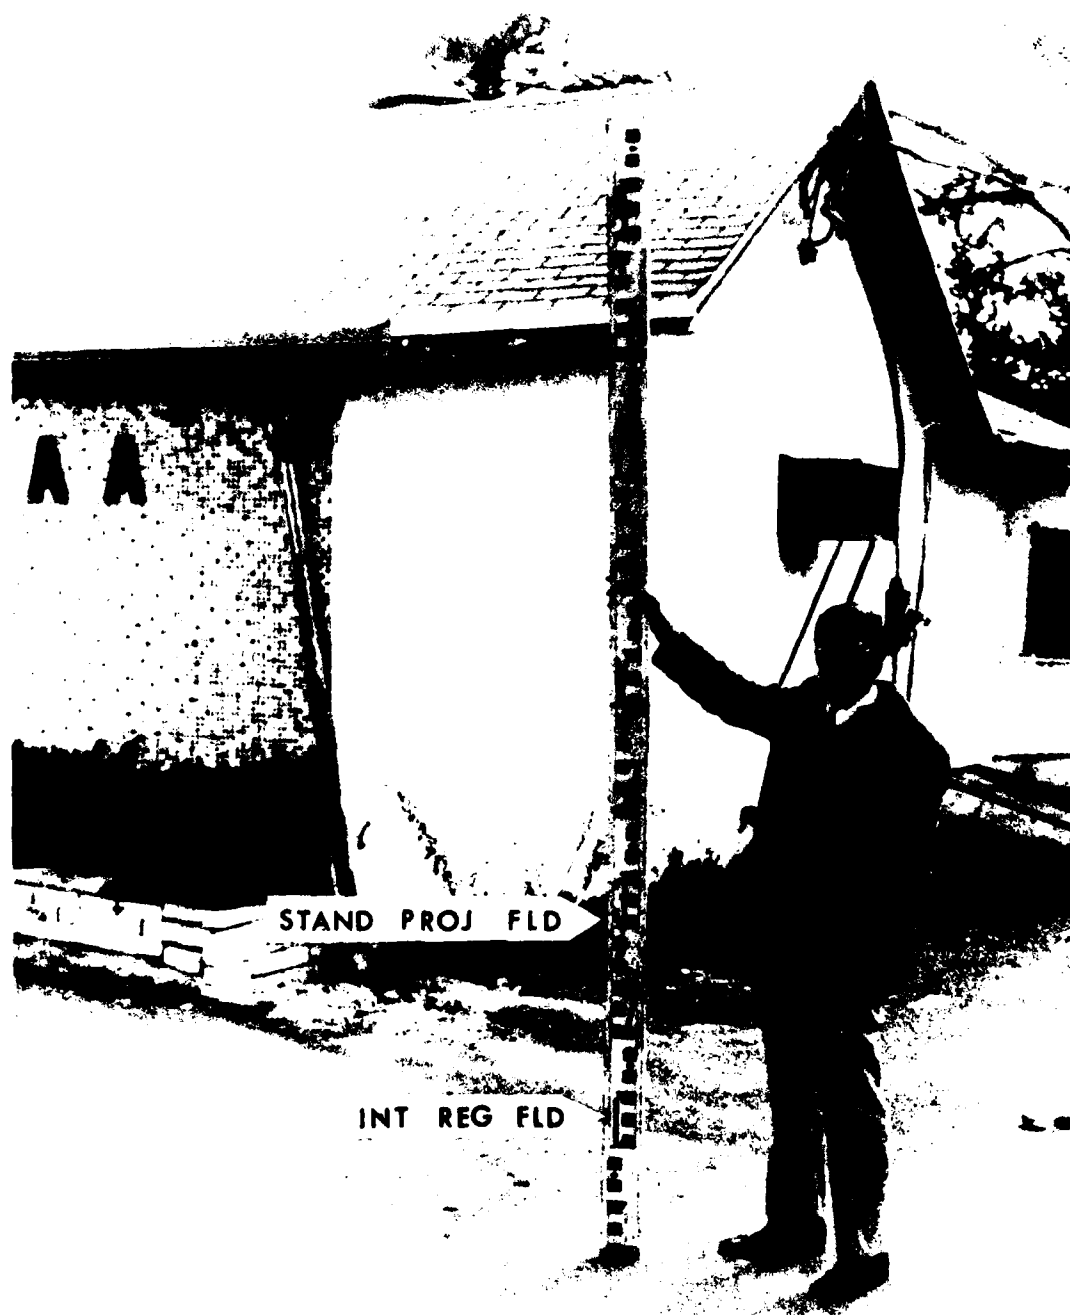
FIGURE 4 - Future flood heights of Antietam Creek at the Stony Creek Athletic Association.

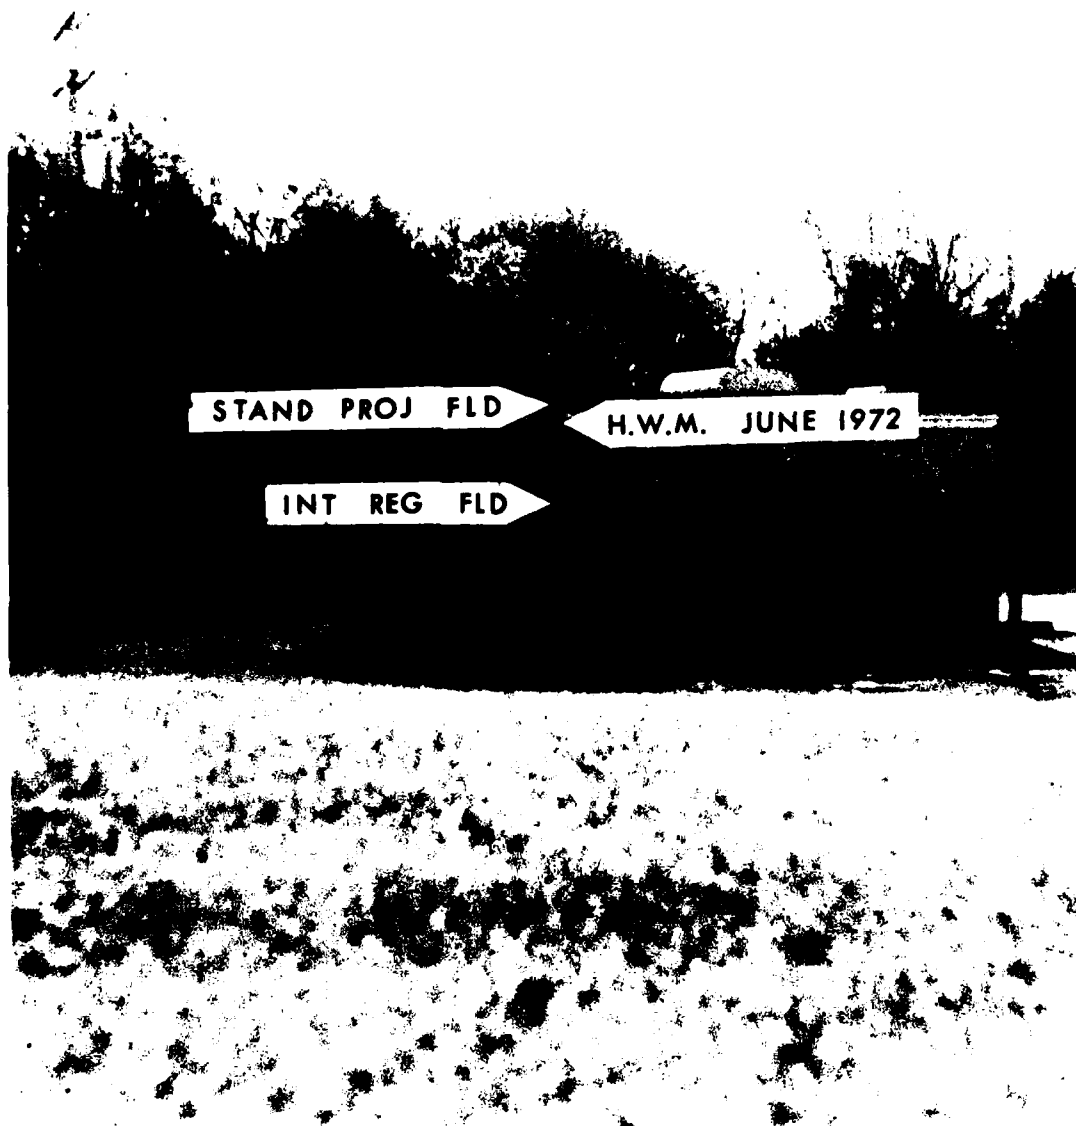
FIGURE 5 - Past and future flood heights of Heisters Creek at the Exeter Township Waste-Water Treatment Plant.

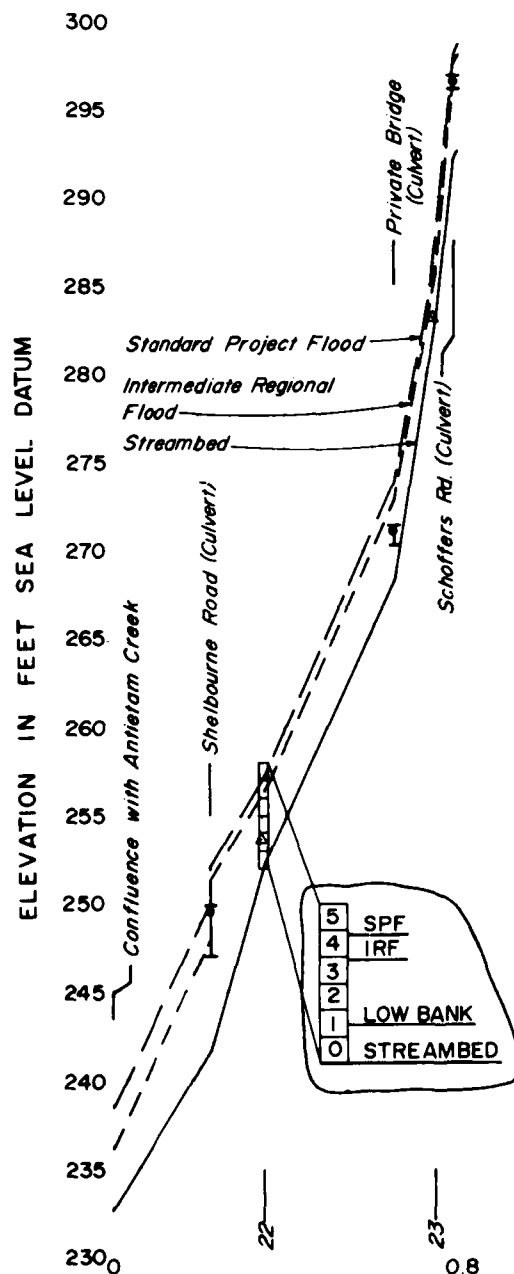
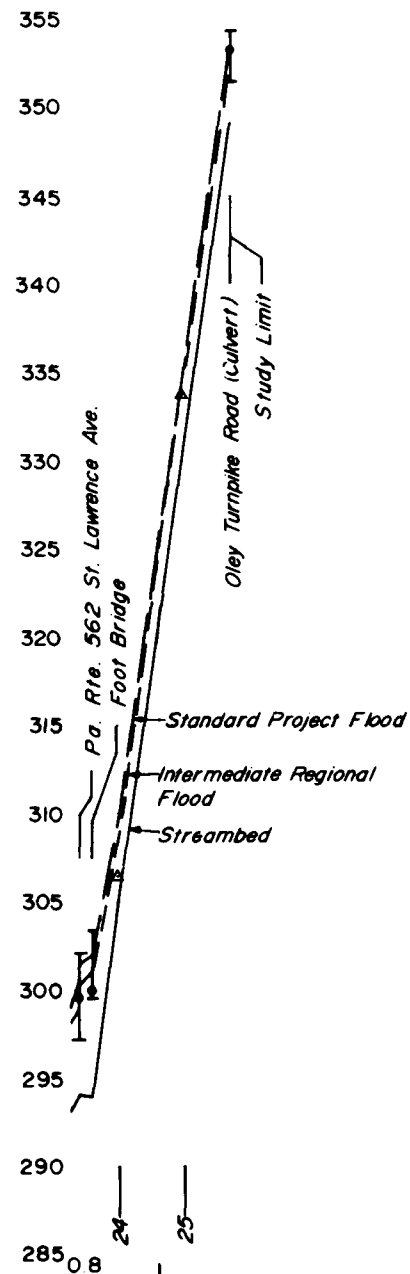
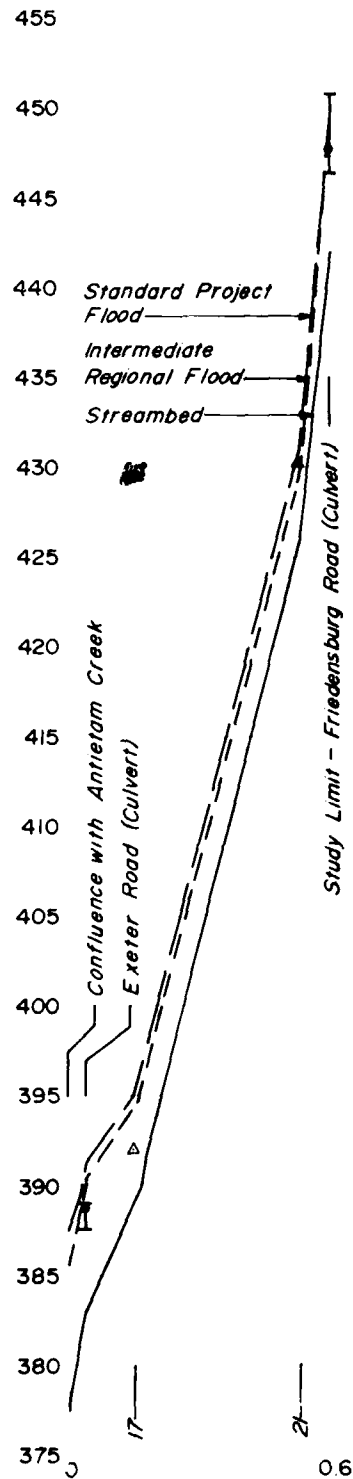
DEPARTMENT OF THE ARMY
PHILADELPHIA DISTRICT, CORPS OF ENGINEERS
PHILADELPHIA, PENNSYLVANIA
FLOOD PLAIN INFORMATION
ANTIETAM AND HEISTERS CREEK
BERKS COUNTY
PENNSYLVANIA
HIGH WATER PROFILES
TRIBUTARIES 1 AND 2

TRIBUTARY I
ANTIETAM CREEK

TRIBUTARY I
ANTIETAM CREEK
(CONT.)

TRIBUTARY 2
ANTIETAM CREEK

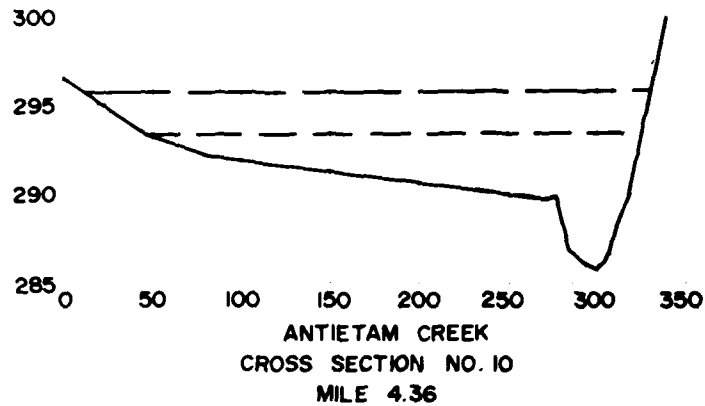
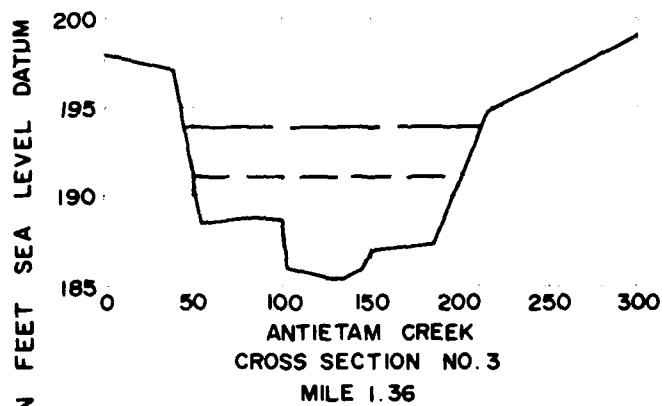
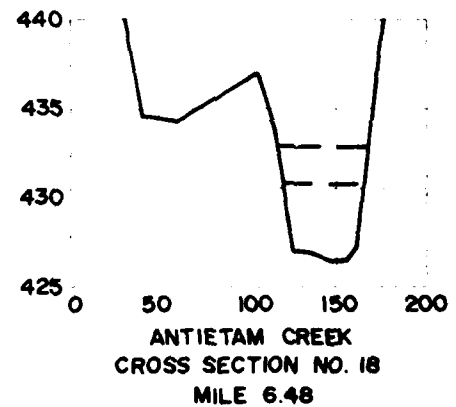
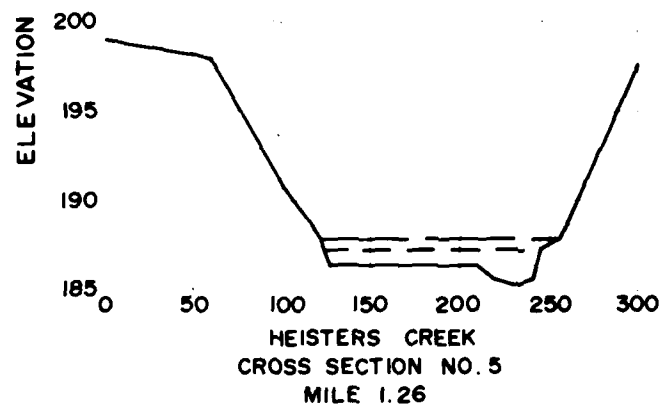
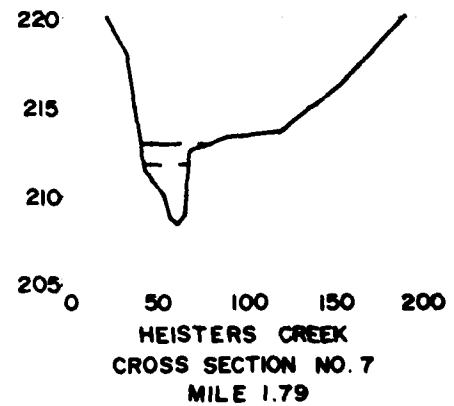
DEPARTMENT OF THE ARMY
PHILADELPHIA DISTRICT, CORPS OF ENGINEERS
PHILADELPHIA, PENNSYLVANIA
FLOOD PLAIN INFORMATION
ANTIETAM CREEK
& HEISTERS CREEK
BERKS COUNTY, PA.
SELECTED CROSS SECTIONS

- Standard Project Flood
- - - - Intermediate Regional Flood
- Ground Line

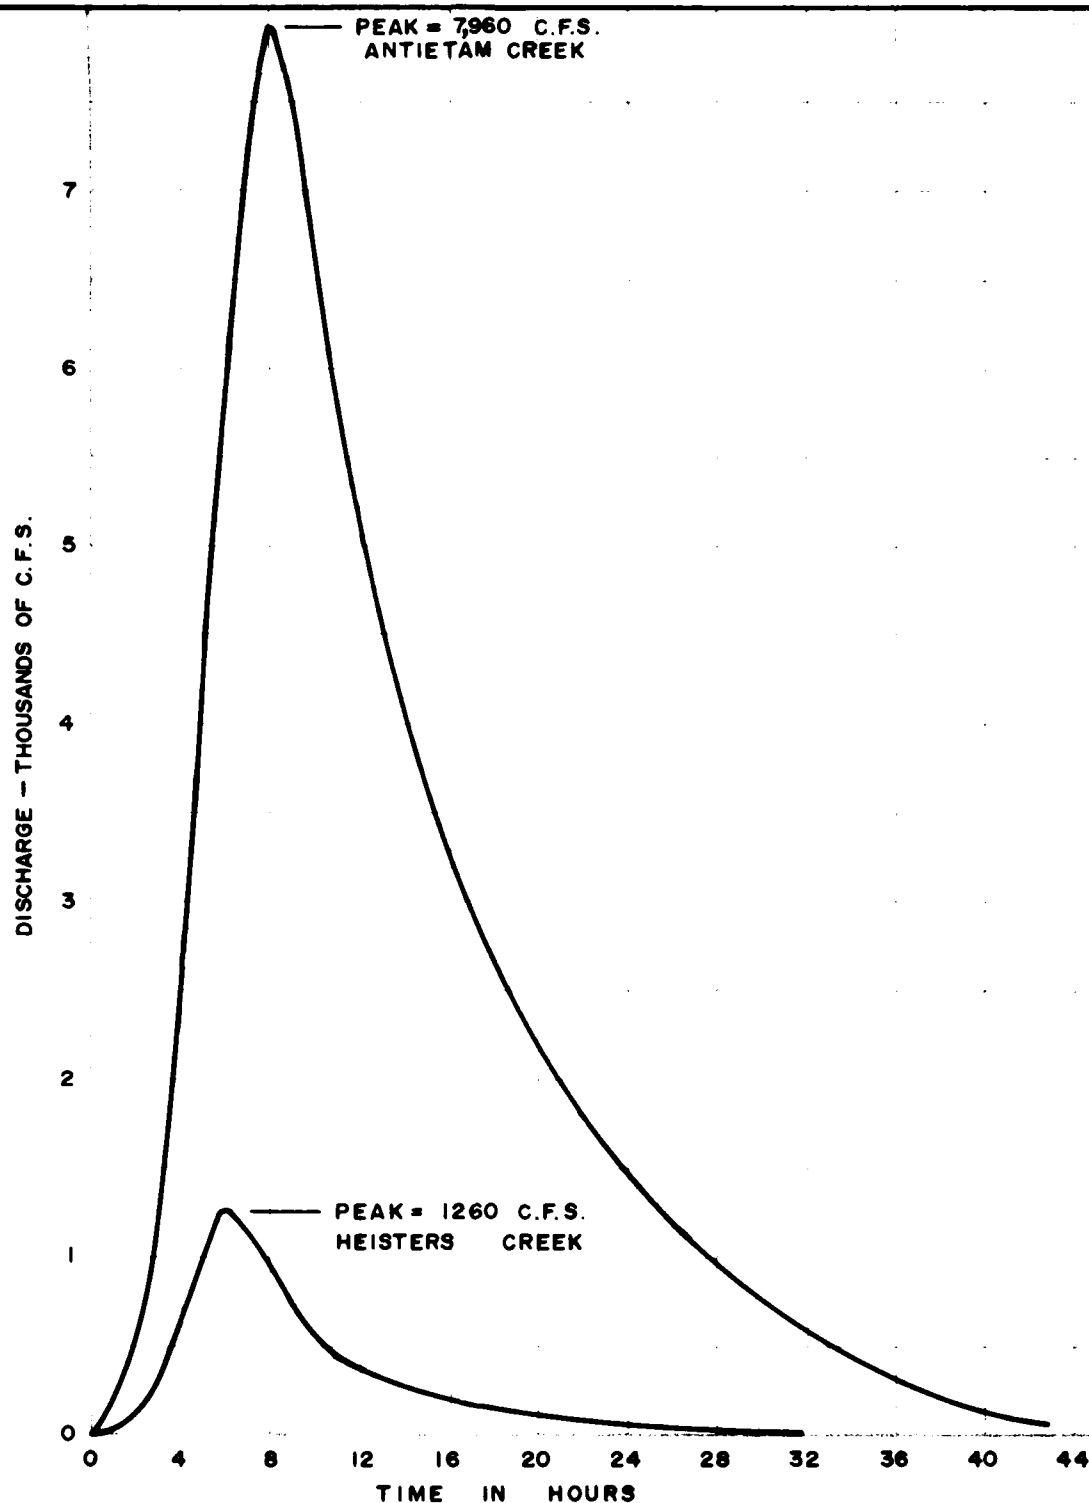
DEPARTMENT OF THE ARMY
PHILADELPHIA DISTRICT, CORPS OF ENGINEERS
PHILADELPHIA, PENNSYLVANIA
FLOOD PLAIN INFORMATION
ANTIETAM CREEK & HEISTERS CREEK
BERKS COUNTY, PA.
STANDARD PROJECT FLOOD
HYDROGRAPHS

HYDROGRAPHS COMPUTED AT
CONFLUENCE WITH SCHUYLKILL
RIVER - STREAM MILE 0.0
